Performance of Wood-Frame Structures during Hurricane Katrina

John W. van de Lindt, M.ASCE¹; Andrew Graettinger, M.ASCE²; Rakesh Gupta, M.ASCE³; Thomas Skaggs, M.ASCE⁴; Steven Pryor, M.ASCE⁵; and Kenneth J. Fridley, M.ASCE⁶

Abstract: The costliest natural disaster in U.S. history was Hurricane Katrina, which made landfall on August 29, 2005 at 7:10 a.m. EDT (6:10 CDT, local time) in Plaquemines Parish, La. Tragically, Katrina caused widespread damage and loss of life but also provided an opportunity to collect data on wood-frame construction which will be useful for design engineers and building code officials in order to design safer and stronger buildings in the future. The objective of this study was to gather and process perishable wind damage data on residential wood-frame structures in nonflooded regions of Mississippi that can be used by the research and design code development community to improve the performance of wood-frame structures to strong wind loading. This study consisted of 3 days of data acquisition of wind damage to wood-frame structures along the U.S. Gulf Coast and was funded by the National Science Foundation. A total of 27 case studies, ranging from entir

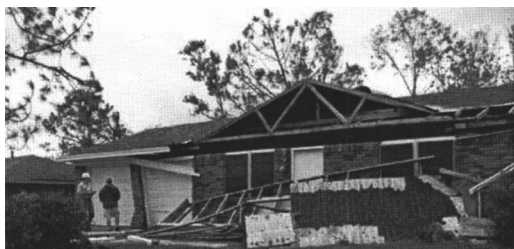
Fig. 4. Porch overhang collapse due to lack of anchorage for support column/post

In the design of structures for wind loading (see ASCE 2005, for a detailed explanation) it is necessary to provide a continuous load path from the roof down to the foundation. In a noticeable number of structures examined, this continuous load path was not present. Fig. 4 shows a photograph of Case Study 7, which was a single-family dwelling with brick veneer whose wood support columns under the porch overhang were not anchored to the concrete. Presumably, the overhang had been built to resist gravity loads and was able to resist moderate winds due to its self (dead) weight. However, with the wind gusts associated with Hurricane Katrina the porch uplifted, the column was blown out, and then the overhang collapsed due to lack of support. Fig. 4 also shows the results of not anchoring the sill plate to the foundation. The wall pier between the two single car garage doors was not anchored, and as a result the bottom pushed inward in excess of 0.3 m (12 in.), nearly causing collapse of that portion of the structure.

In many cases the porch roof diaphragm is framed back into the roof system, thus failure of the porch overhang resulted in a significant breach of the structural envelope and subsequent water

damage from numerous inches of wind-driven rain resulted. It also allowed the attic areas to become internally pressurized, further adding to damage.

4. Support columns/posts should be anchored to both the roof and foundation, particularly in high wind regions such as the Gulf Coast.
5. Architectural shingles tended to remain intact more often than regular roof shingles.

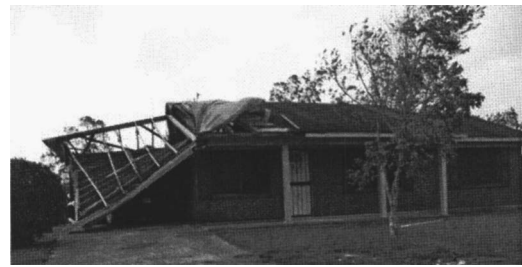
Fig. 5. Carport collapsed and structure breeched

The same type of failure was seen in carports, whose support columns/posts were not properly anchored to the concrete. Fig. 5 shows an example of this type of failure for a carport. This type of failure was not seen when wood to concrete hold downs were used at the base of support posts. The correct use of this type of connector is shown pictured in Fig. 6. The aesthetic vinyl wrap was peeled off but the support post, and subsequently the porch overhang and roof, remained intact.

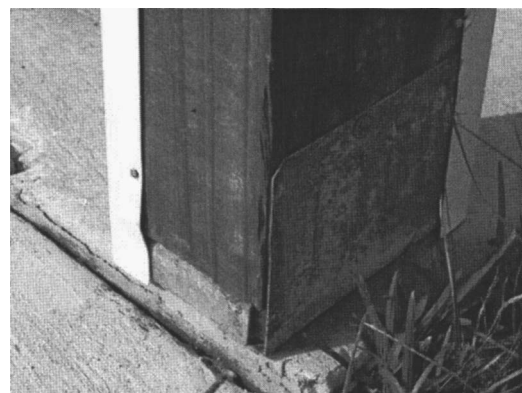
Fig. 6. Wood to concrete connection at base of porch overhang support post

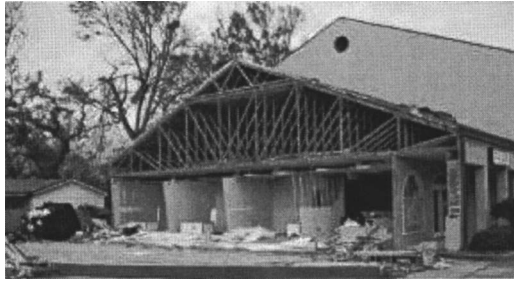
Fig. 7. Loss of CMU wall that was not properly connected to the structure

Fig. 7 shows a photograph of an unreinforced masonry wall (CMU) (Case Study 20) located next to a light commercial wood-frame building. The CMU wall was essentially free standing as it was only connected to the structure by light gauge flashing along the gable roof line. Fig. 8 shows a photograph of a similar situation (Case Study 19) where the brick veneer on a wood-frame apartment building was lost. This may have been the result of a parapet detail which allowed pressurization.

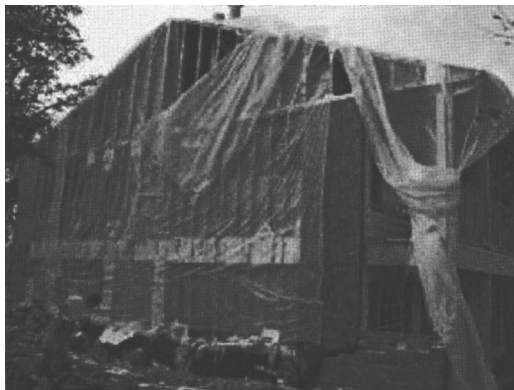
Fig. 8. Loss of brick veneer due to lack of anchorage

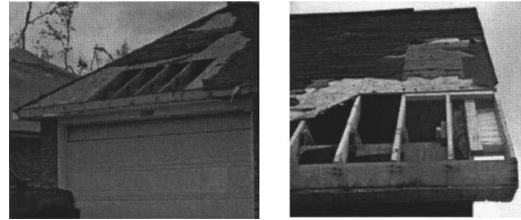
The perimeters, including corners, of roofs typically experience the highest uplift pressure during wind storms. Loss of roof sheathing was observed at the perimeters and corners in numerous cases. It was also observed that when roof sheathing was lost it was not attached with the current code minimum nail spacing of 160 mm (6 in.) on-center for the perimeter and 320 mm (12 in.)

Fig. 9. Roof sheathing damage; a heavier nailing schedule may help protect against this type of damage

on-center in the field. Figs. 9 and 10 (Case Study 9) show typical roof sheathing loss as a result of Hurricane Katrina winds. Using nail spacing that meets the code minimum would have most likely reduced loss of sheathing in the Mississippi Gulf Coast region.

3. A closer/heavier nailing schedule for roof sheathing may be helpful in reducing the amount of roof sheathing loss due to uplift, particularly at the edges and corners, and result in significantly less water intrusion. In many cases the current code minimum spacing was not being met.

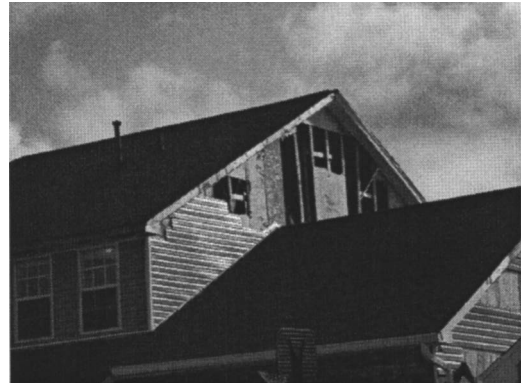
A common failure that was observed was the loss of sheathing on the gable end walls, as shown in Figs. 10 (Case Study 23) and 11 (Case Study 25). There are two possible causes: The vinyl siding was lost, and the wind caused failure of the foam sheathing, or air entered through attic vents or other means and pressurized the attic dislodging one or more sections of nonstructural sheathing. The latter of these may have resulted in the breach of the building envelope that allowed wind driven rainwater to enter the building causing significant damage. The rainwater saturated the ceiling insulation resulting in the failure of the gypsum/drywall ceiling.

Fig. 10. Loss of nonstructural sheathing at the gable end wall

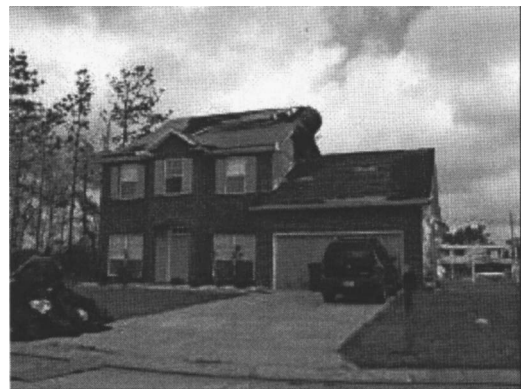
Fig. 11. Loss of gable end wall, roof shingles and sheathing, and garage door (note the debris bags to the left of the driveway)

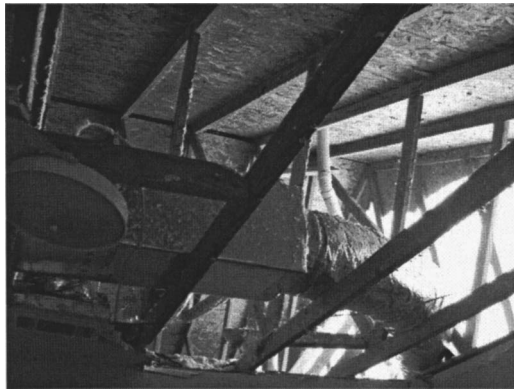
Fig. 12. Second floor bedroom that was very badly damaged due to the loss of nonstructural sheathing on the gable end wall

Fig. 12 shows a photograph from inside a second floor bedroom of the house in Fig. 10. The structures shown in these photographs had been severely damaged by rain water and were in the process of being renovated. According to one homeowner, the repair estimate was equal to the cost of the home when it was built in 1999.

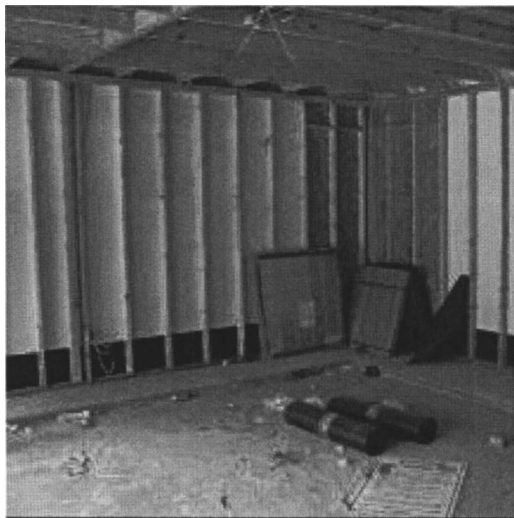
Recall the brief description of the three types of construction practices commonly associated with wood-frame construction. It was observed that most or all of the construction in this region is based on conventional construction which does not require any engineering calculations. An example of this is shown in Fig. 13 (Case Study 21) where 1.22 m (4 ft) wide braced panels were placed at the ends of a 7.62 m (25 ft) exterior wall without any hold downs to resist lateral (e.g., wind) forces. It should be noted that ASCE-7 (2005) shows this region having a design wind speed of 130–140 mi/h (209–225 kph). These high winds would result in these areas falling out of the scope of conventional building code provisions such as the International Residential Code, thus the need for engineered construction including possibly the use of hold downs. This results in engineering calculation for the

Fig. 13. Braced-wall panels (prescriptive) at the ends of an exterior wall in a region having a design wind speed of 130–140 mph

width of shear wall (in place of braced panel) along with nailing and anchoring requirements. As an alternative to detailed calculations, these structures could have been built following the *Wood-Frame Construction Manual* (AF&PA/AWC 1995) which is a prescriptive code but is based on engineered loads and load paths. Yet another alternative would be the use of the engineered wood code (NDS (ANSI/AF&PA) 2005) which requires engineering calculations. If the wall in Fig. 13 was designed using engineered code or calculations, the shear walls at the ends of the wall may have been more than four feet long with stricter nailing requirements and hold-downs at the ends of the shear walls. It appears that inspectors and builders seem to be familiar with conventional construction in this region but there were multiple cases where homes should not fall under this provision.

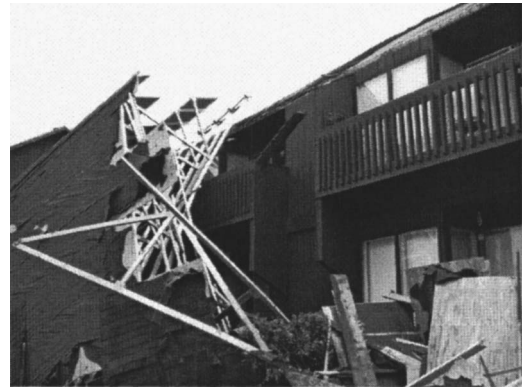
Fig. 14. Condominium roof, retrofitted onto the original flat roof, failed after approximately 4 h of wind gusting

It was observed that seemingly small details that were not addressed, such as a lack of nails in hurricane clips, resulted in failure. Fig. 14 (Case Study 15) shows the remains of a condominium roof that lifted off after 4 hours of wind gusting (according to an eyewitness). Fig. 15 shows a close-up of a hurricane tie that did not have the recommended number of nails. Another example of inadequate load transfer was also observed in the same condominium community. An entire roof, truss system, and top plate lifted off a structure. In that case, the truss uplift forces were transferred adequately to the top plate, but the top plate had no mechanism to transfer the load to the wall assembly, since the top plate was not anchored properly. The result was complete loss of the roof system.

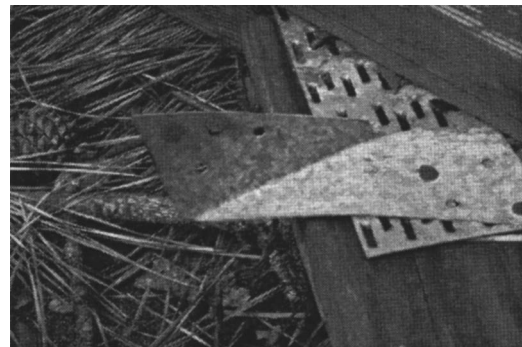
Fig. 15. Hurricane clip connecting a roof truss and wall (note that the proper number of nails was not used)

6. Careful attention must be paid to all details, particularly the (correct) use of all straps and ties, to ensure a continuous load path from the roof to the foundation. This includes proper anchor bolt positioning and use.

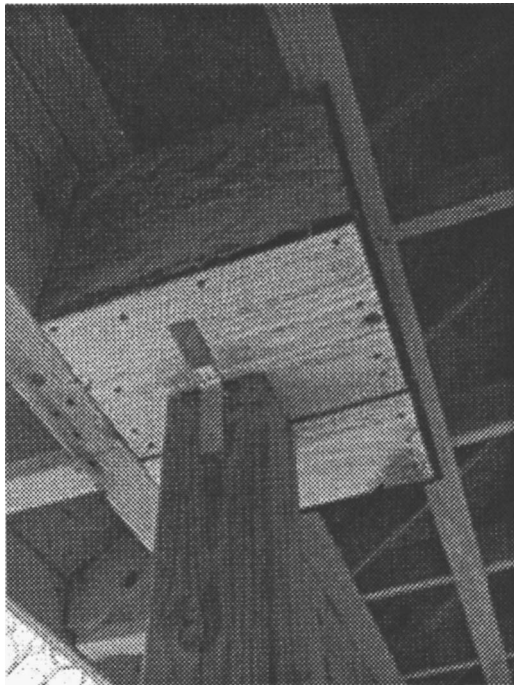
Fig. 16. Misuse of uplift strap

Further, in Fig. 16 (Case Study 17) is a strap that has been field modified in the shape of an “L.” It is not clear what the design requirements are for this particular connection, but such modification renders the strap ineffective for uplift resistance. Connections such as this strap should always be installed in accordance with the manufacturer’s recommendations to ensure that it performs as expected.

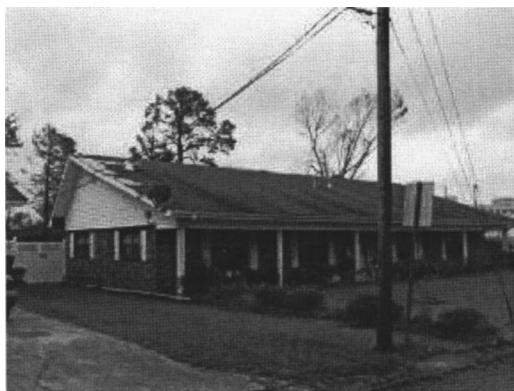
In the majority of case studies investigated there was some amount of roof shingle loss, which is consistent with other observers (Kirby and Scislo 2005). Many of these buildings were covered with temporary tarps four weeks after Katrina when these observations were made. Based on investigation as well as discussions with homeowners, architectural roof shingles tended to perform better than normal roof shingles. It should be noted that

Fig. 17. Loss of roof shingles on an older home; this was quite common for regular roofing shingles

only newer residential structures had the option to use these high wind shingles. Fig. 17 (no case study number) shows the loss of roof covering for a typical wood-frame residential structure in the area. Loss of shingles was common to both older and newer structures in all areas studied even though these areas did not experience winds in excess of 100 mi/h (161 km/h). It should be noted that in recent years the design wind speed has been increased and therefore many of the structures investigated were not built to present code (Kirby and Scislo 2005).

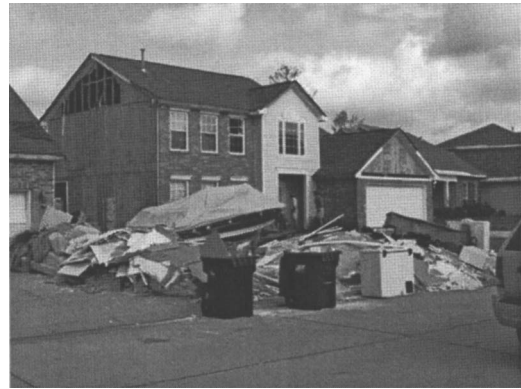
Fig. 18. The result of vinyl siding and nonstructural sheathing loss left just a shell for many of the homes in this subdivision

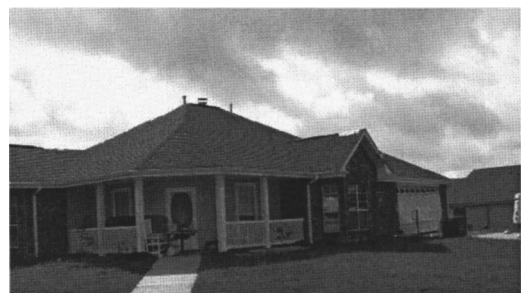
Fig. 19. Damage to the top right trim piece on the roof just left of the garage; this was the only damage to this one-story house with a hip roof

ASCE-7 (2005) design wind speeds, thus the amount of observed trim damage could potentially be considered excessive. Fig. 19 shows damage to the trim of a gable roof just to the left of the garage on a home that fared quite well. Many two-story homes just across the street did not perform as well with significant nonstructural and some structural damage, as shown earlier in Figs. 11–13 and 19. In this particular subdivision, one-story houses performed much better than two-story houses, possibly due to localized wind effects.

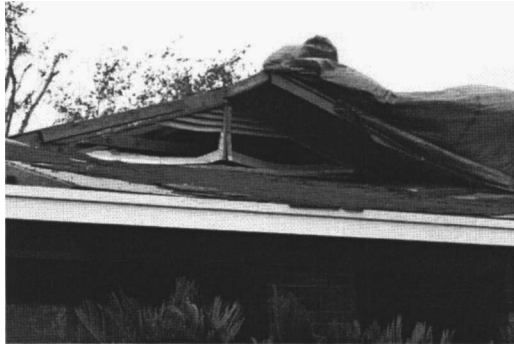
Fig. 20. Attic vent allowed attic to pressurize and roof sheathing to fail

Attic vents were a common entrance for wind flow resulting in pressurization of the attic and failure of the roof sheathing and interior ceiling drywall. Fig. 20 (Case Study 11) shows a damaged attic vent and roof sheathing in a 1970s one-story home. Attics that were vented using perimeter ventilation near the soffit typically performed better than structures with attic vents located on the gable. This trend was common for both older and newer wood-frame residential construction.

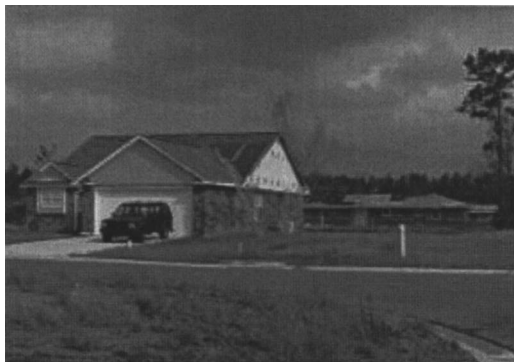
Although there were many older residential wood-frame houses that performed well, the general trend was that newer homes tended to sustain less structural and nonstructural damage. Fig. 21 (Case Study 12) shows a picture of new homes, very recently constructed, in the foreground and older circa 1970s homes in the

Fig. 21. Newer home with very little structural or nonstructural damage in the foreground; older neighborhood in the back ground with most structures having significant damage

background. The difference in the sustained damage levels was notably higher in the older structures. It may be inferred from this that design code changes, following Hurricane Andrew in 1992, were likely successful.

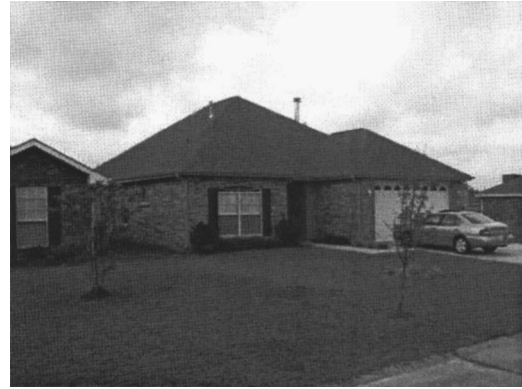
Fig. 22. Example of a hip roof, which performed very well during the hurricane winds

Hip roofs performed significantly better than gable roofs. Fig. 22 is an example of a hip roof that performed significantly better than gable roofs during the hurricane. This was the trend throughout the study area, shown in Fig. 2, and for both one- and two-story houses.
